Arboricultural Impact Assessment

Tulfarris CG LTD

Cloonmore Regeneration LRD

Housing Scheme

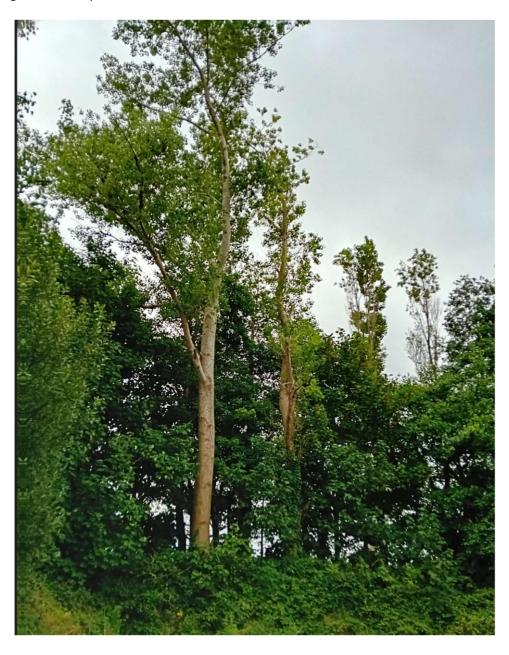
The site consists a private residential house with the prinipal trees planted within the lawn area east of the entrance. The western boundary is a green field with little vegetation of significance. The rear of the property contains a orchard, there are also a row of large mature Poplar trees that are not suited to the site and maybe a potential hazaed fo the new development.

Row of large mature Poplar at the rear of the site, these are recommended for removal

Tree	Species	Age	Size	Height	Crown	Crown	Condition	Structural/Physiological	Impact of the	PMR	Category	RPA
No		class	(mm)	(M)	Sp. (M)	CI.(M)		Observations	development			
1008	Beech	М	480	8	N=3	1	Good	A mature beech displaying good condition	Remove to	Remove	B2	
					S=3				facilitate ethe			
					E=3				development			
					W=3							
1009	Beech	М	300	8	N=3	2	Good	A mature beech displaying a good overall condition	Remove to	Remove	B2	
					S=3				facilitate ethe			
					E=2				development			
					W=2							
Group 1	Scrub willow	EM	100	4	N=3	1	Poor	a large scrub area	Remove to	Remove	C2	
					S=3				facilitate ethe			
					E=3				development			
					W=3							
Group 2	Leyland cypress x	М	200	12	N=2	1	Fair	a row of leylandii that have been left unmanaged	Remove to	Remove	C2	
	15				S=2				facilitate ethe			
					E=1				development			
					W=1							
Tree	Poplar x 10	М	500	18	N=3	2	Poor	A row of large mature poplar many have suffered limb	Remove to	Remove	C2

Line 1					S=3			loss. These are in poor condition and are no longer	facilitate ethe			
					E=3			appropriate for the site.	development			
					W=3

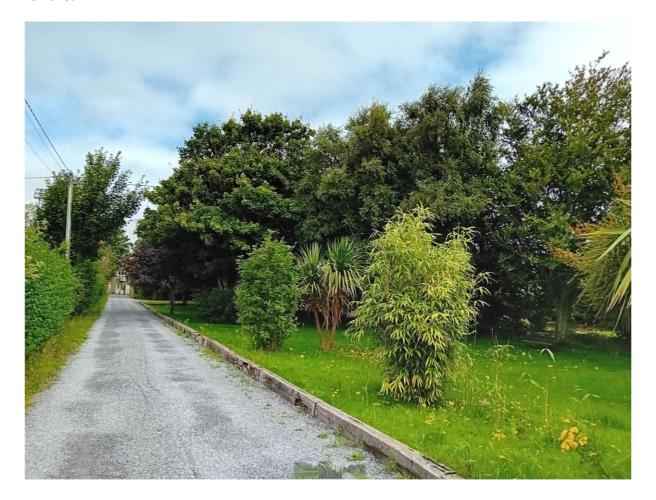
A view of the main avenue looking out, note the majority of he trees within the lawn area will be removed
